Insignia NS-CLIP02 Power Auxiliary Port Replacement Replacement

Written By: Erik

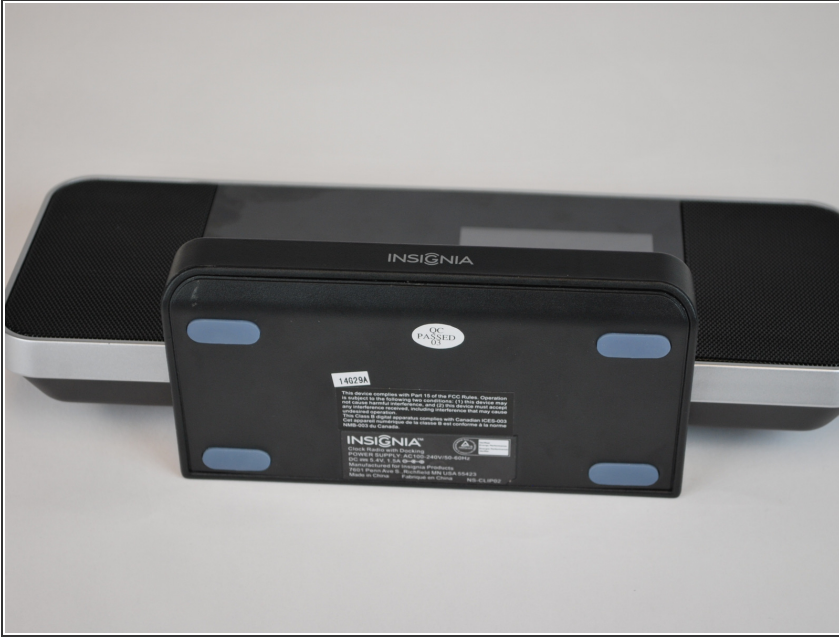
Step 1 — Power Auxiliary Port Replacement

- Locate the bottom of the device.

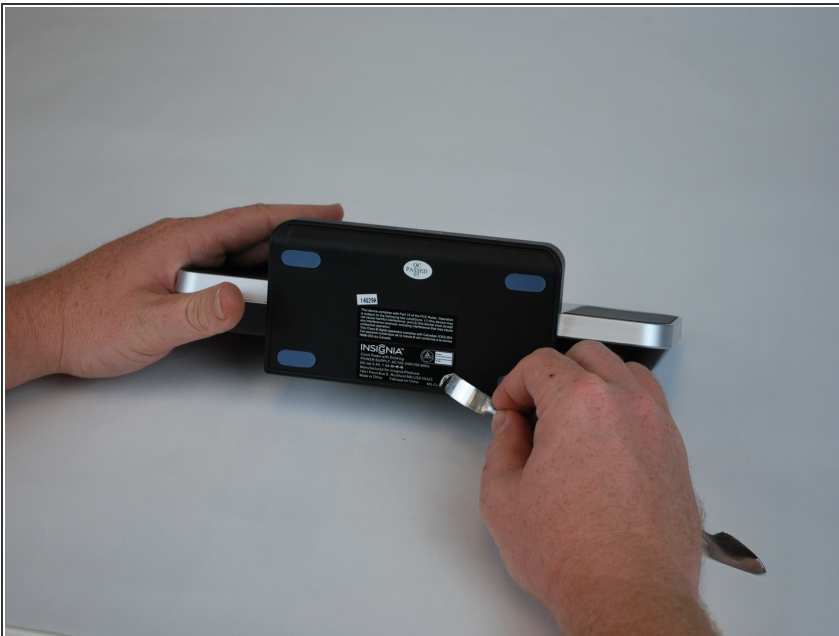
Step 2

- Begin by using a metal spudger to peel back the adhesive sticker and locate the 11mm screw beneath the sticker.

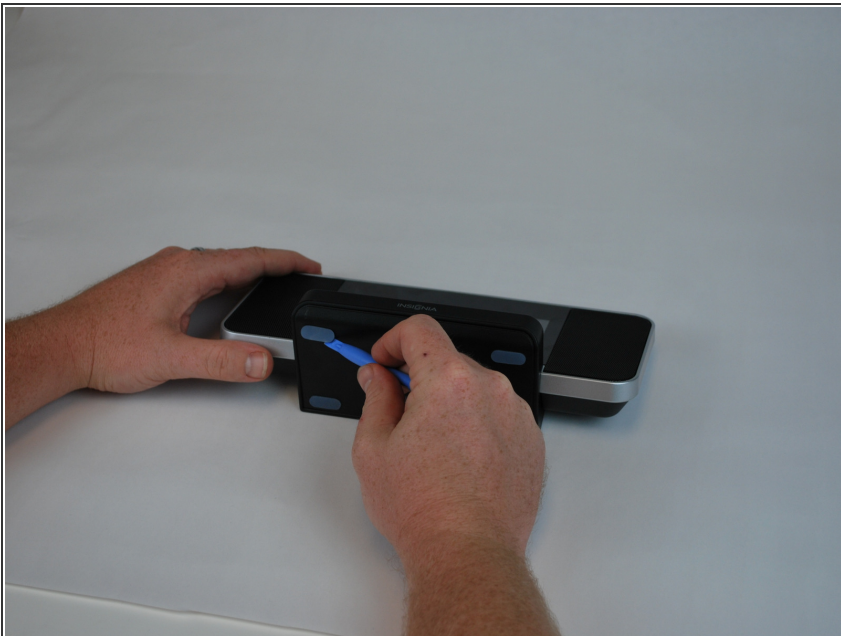
Step 4

- Using a plastic spudger, peel off the adhesive gel stoppers.

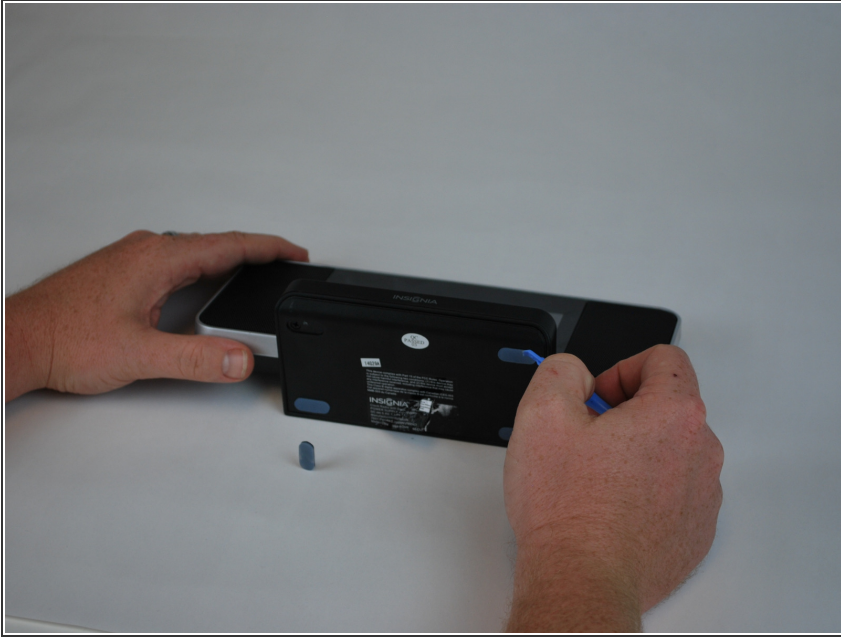
Step 5

- Continue peeling the rest of the gel stoppers from the bottom of the device.

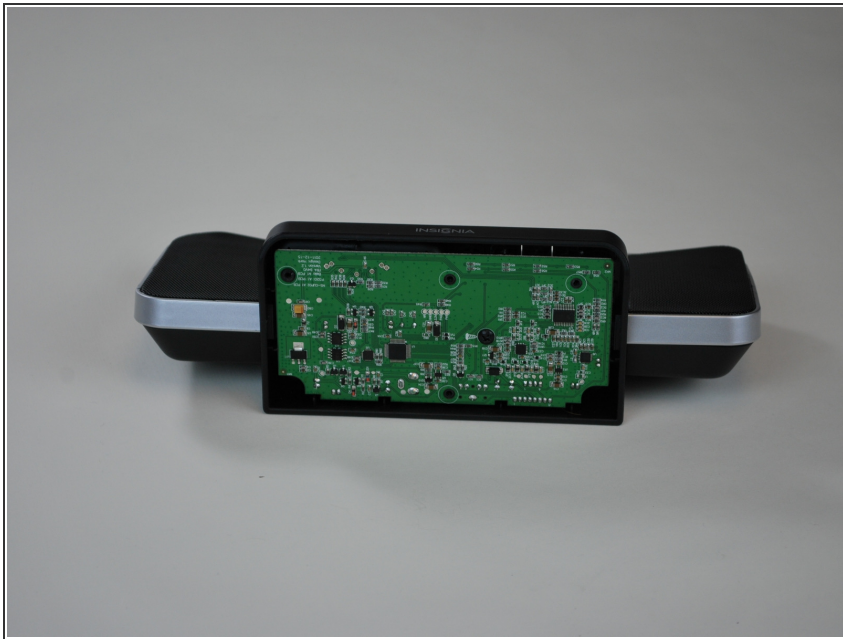
Step 7

- Once you peel of the bottom from the device, you will see the motherboard.

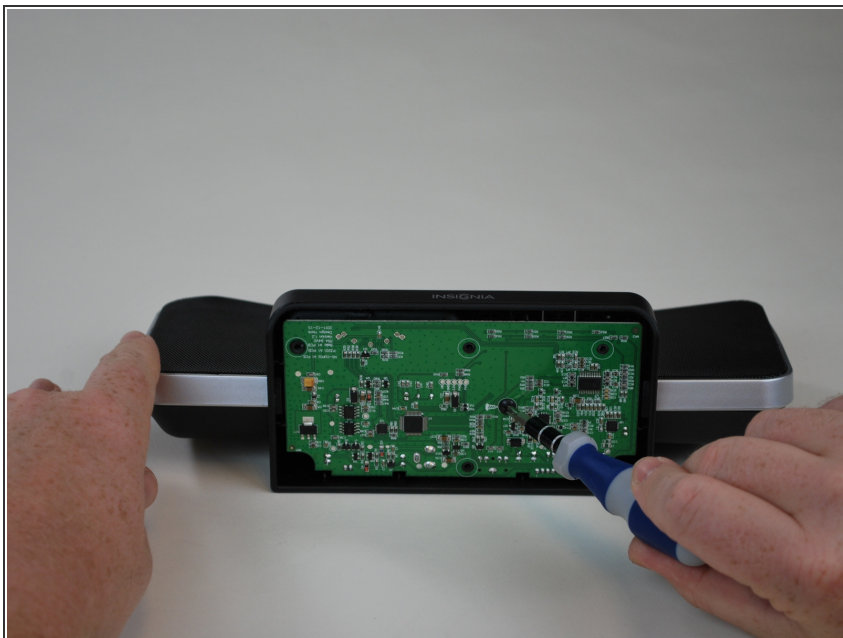
Step 8

- Unscrew the 9.5mm screw located near the center of the motherboard with a Phillips head screw driver.

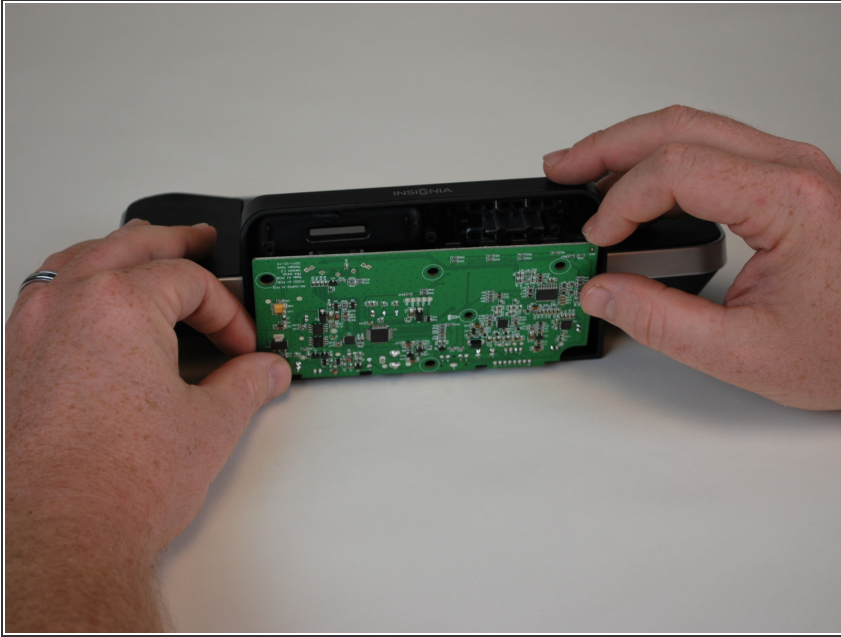
Step 9

- Lift the motherboard from the device.
